Environmental Engineering and Management Journal

NUTRIENT REMOVAL IN A WET DETENTION POND WITH BAFFLE DIKE – A CASE STUDY OF THE CEDAR RIVER PROJECT

Killian Eckert¹, Christopher J. Brown^{2*}, Greg McGrath³, Shayne Wood³

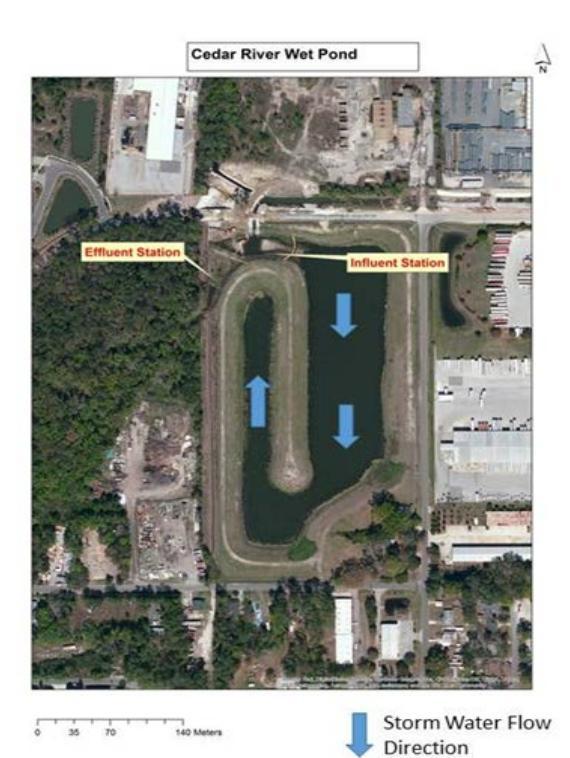
Fig. 2. Detailed project features

The Cedar River wet detention pond has long been envisioned to improve the water quality of the study area. The Cedar River watershed has had significant sediment contamination from a number of historical industrial sites as well as a history of high fecal coliform counts. In the mid-1990s, over 75% of all samples analyzed for fecal coliform were found to exceed the single sample Florida limit (800 CFU per 100 mL of water sample) and the mean value was about 10 times the permissible limit (UNF and JU, 2011). The Cedar River watershed additionally has been recognized since at least 1983 as having been burdened by years of discharges from wastewater treatment plants and runoff from small, poorly managed industries, and from identified and unidentified hazardous waste sites (UNF and JU, 2011). Fig. 1 shows the general location of the project site in Florida, USA and Fig. 2 is a detailed aerial photo showing the general project features.

Composite surface water quality samples were taken for each event by automatic samplers installed at the influent (CRV1) and effluent (CRV2) station locations of the facility (Fig. 2). Oil and grease sampling was conducted via grab sample because the automatic sampler intakes were submerged and would therefore not sample the pond surface where oil and grease accumulate. The automatic samplers were programmed using site-specific criteria and expected water quality conditions seen at similar storm water treatment areas (Harper and Baker, 2007).

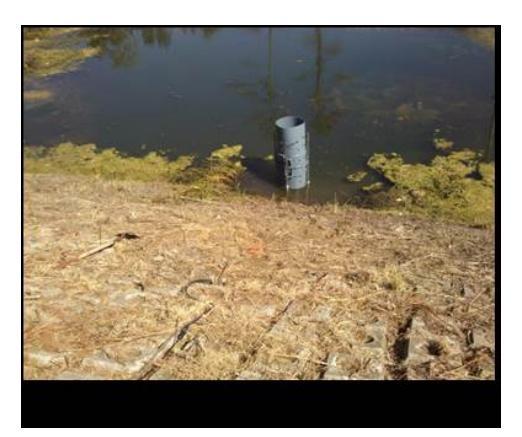
Fig. 3. Sampling station

Station CRV 1 was located at the influent end of the facility. Fig. 3 and Fig. 4 show the stilling well containing the autosampler influent station and the actual sampling equipment stored in a secure cage. The sampling equipment was installed in a secure cage on a concrete slab at the top of the maintenance berm. The use of the secure cage was important as the project location is located in an area where vandalism is common. The sampling equipment was initially enclosed by chain-link fencing and later heavy-duty metal bars to prevent theft. The pond influent location CRV1 was located at the bridge, just south of the confluence of two channels. Station CRV2 was located at the effluent end of the facility. The sampling equipment was installed, similar to CRV1, on a concrete slab on top of the maintenance berm. The sampling equipment was enclosed identically to CRV1. The sampling at the effluent location was performed at the outfall of the facility within the RCP culvert that allows treated storm water to drain from the facility as fresh storm water enters the facility at the influent end. Stations CRV1 and CRV2 contained the following equipment:

Sampling of the influent storm water took place near the edge of the channel inside of a custom-built stilling basin. The stilling well was built to mitigate disturbance to the area velocity sensor by floating debris, animals, etc., in order to measure water levels more accurately and prevent false triggering of sampling due to water surface disturbances. The automatic sampler was connected to the area velocity sensor and sample intake strainer by a length of data cable and sampling tubing that were buried just below the ground surface. CRV1 contained a two-part (A and B) sampling program which initiated part A upon both of the following criteria being met:

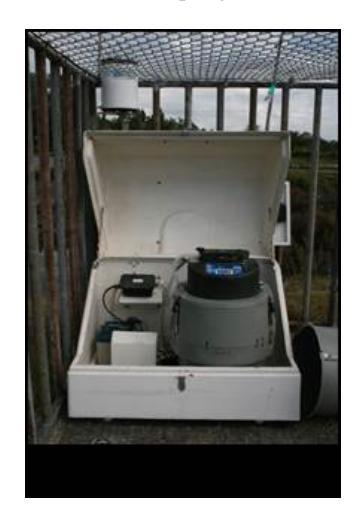
Fig. 4. Sampling equipment

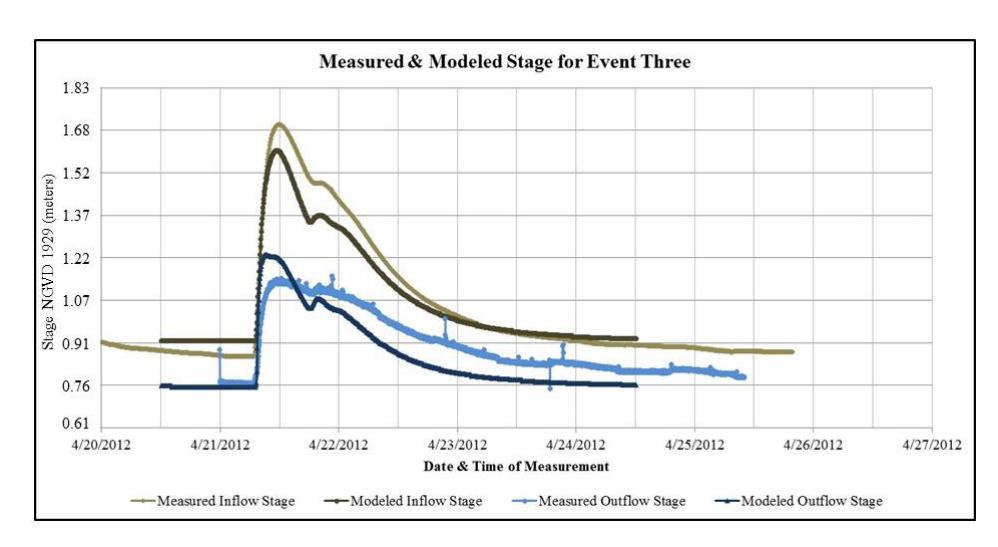
Fig. 5. Comparison of measured and modeled inflow and outflow for event 3

Data that were collected by the automatic samplers for each storm event was analyzed and compared. Both onsite instrumentation data and model simulations were used in the overall analysis. The project team was fortunate that an existing EPA SWMM storm water hydraulic model had been previously developed and calibrated for the entire City of Jacksonville service area (CDM Smith, 2007) including the project site. Therefore, the model proved useful in refining estimates of basin performance, especially in cases of lower flow rates where the model provided better estimates of the water budget as compared to the instrumentation. Analysis consisted of utilizing rainfall measurements taken by CRV1 and developing a simulation for each storm. Each simulation produced a modelled inflow and outflow volume, as well as a modelled pond stage. Graphical comparisons made between the modelled and measured flow and stage data demonstrated that the hydraulic model of the site was generally accurate and provided better estimates of the outflow than using onsite instrumentation alone (see Fig. 5 with an estimated r² value of 0.95 for measured versus modelled inflow as an example).

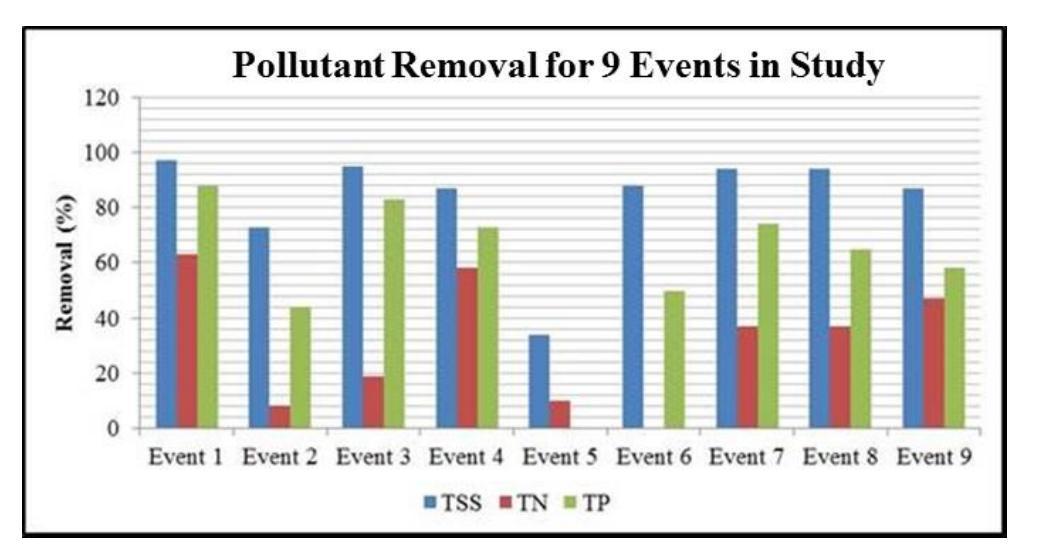
Fig. 6. TSS and nutrient removal performance for all events

Overall the TSS and nutrient removal performance of the innovative wet detention pond was satisfactory and exceeded design goals. Table 1 compares the original performance design goals and typical wet detention pond performance in Florida versus the actual arithmetic mean measured nutrient removal efficiencies for the project. The mean removal efficiencies were used instead of the median values to be conservative in the performance comparisons as the median values were higher. The Cedar River pond greatly outperformed its conservative design goals with more than triple the removal efficiency for TN, more than double for TP, and 22% better for TSS.

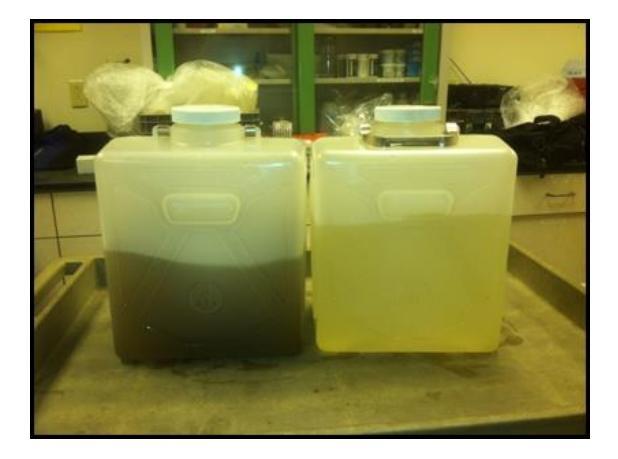
Fig. 7. Influent (left) and effluent (right) water samples collected during the study

Besides the actual analytical results collected for the study, overall project performance is also easily recognized by visually comparing the color of the influent and effluent. Fig. 7 shows storm water before and after wet detention treatment.
